**THERMAL  
PRE-SALE  
PROPERTY  
INSPECTION**

**TIMBER PEST**

1.0 CLIENT DETAILS:					
<b>Client:</b>	Silas Sutherland & Janine Elizabeth Watson				
<b>Contact Details:</b>	Ph: C/- 0404 158 364 Email: C/- dave@davet.com.au				
<b>Job Invoice No:</b>	102289				
<b>Inspection address:</b>	25 Sunset Avenue Woolgoolga				
<b>Inspection Date &amp; Time:</b>	<table border="1"> <tr> <td><u>Date:</u> 23/03/2021</td> <td>Arrival Time: 08:30</td> </tr> <tr> <td></td> <td>Departure Time: 10:30</td> </tr> </table>	<u>Date:</u> 23/03/2021	Arrival Time: 08:30		Departure Time: 10:30
<u>Date:</u> 23/03/2021	Arrival Time: 08:30				
	Departure Time: 10:30				
<b>Weather Conditions at time of inspection:</b>	Raining				
<b>Building if Furnished:</b>	Yes, the dwelling was fully furnished and all cupboards & built-in robes were full of the occupier's stored goods throughout at the time of this inspection				
<b>Building Tenancy:</b>	Occupied				
<b>Persons present at time of inspection:</b>	Vendor

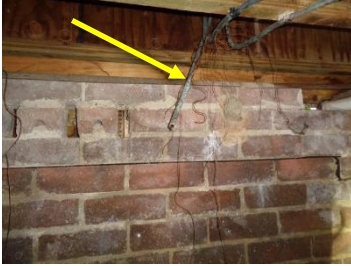
**5.29** Hot Water services and Air Conditioning units that do release water alongside or near external walls need to be connected to a drain. If this is not possible then their water outlet needs to be piped several meters away from the building as this is highly conducive to termites.  
Is there a need for this work to be carried out? **Yes, the HWS overflows into the subfloor and should be diverted.**

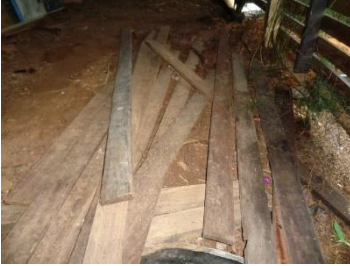
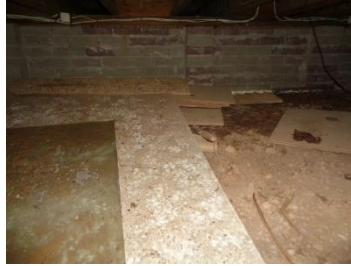
**5.36** Other areas and / or situations that appear conducive to (may attract) subterranean termite infestation: **Loose timber stored below the rear deck and in the subfloor can attract termites.**

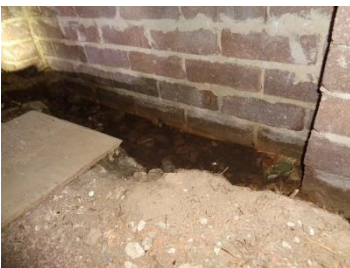
**Water pooling in the subfloor along the foundation wall can create a damp area conducive to termites.**

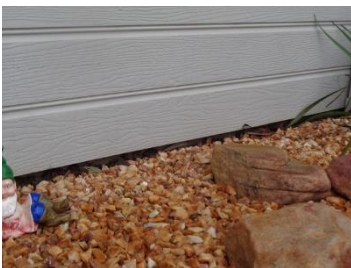
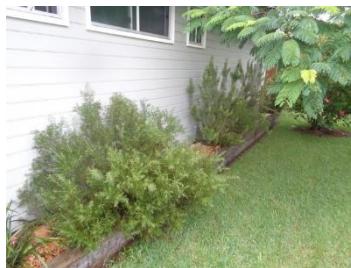
**5.43 Other areas and/or situations that may allow undetected subterranean termite entry:** We itemise any other situations that may allow termite entry and they are: **Garden beds against the front foundation wall can allow undetected termite entry.**

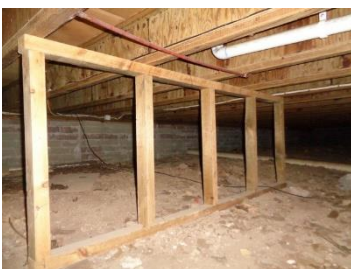
**The timber support frame below the kitchen bench is on contact with the foundation soil and the floor joists, this can allow undetected termite entry.**
